Home report

property questionnaire

42. NOLT LOAN RD
AR BROATH
DD 11 2AH

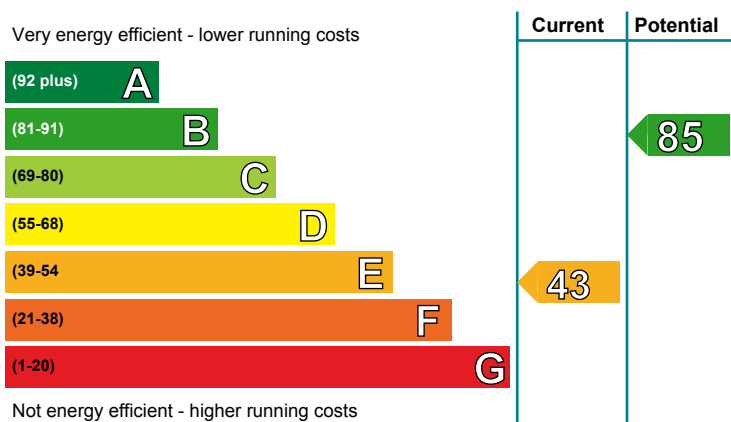
Energy Efficiency Rating

This graph shows the current efficiency of your home, taking into account both energy efficiency and fuel costs. The higher this rating, the lower your fuel bills are likely to be.

Your current rating is **band E (43)**. The average rating for EPCs in Scotland is **band D (61)**.

The potential rating shows the effect of undertaking all of the improvement measures listed within your recommendations report.
