# Home report

Property address  26 ALEXANDER GORDON DRIVE	
MONIFIATH DD5 4HD	
Seller(s) GAVIN + ANN MUIR	
Completion date of property questionnaire 16/01/2020

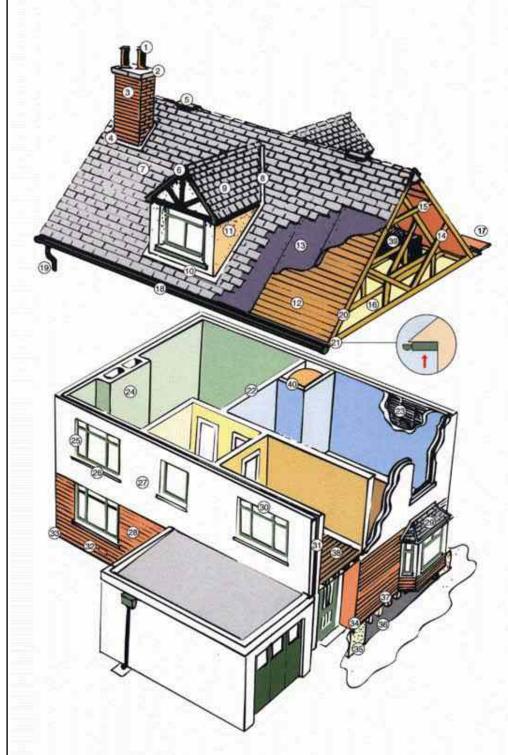
## Sectional Diagram showing elements of a typical house

Reference may be made in this report to some or all of the above component parts of the property. This diagram may assist you in locating and understanding these items.

- 1) Chimney pots
- 2 Coping stone
- 3) Chimney head
- 4) Flashing
- (5) Ridge ventilation
- 6) Ridge board
- 7) Slates / tiles
- (8) Valley guttering
- 9 Dormer projection
- 10 Dormer flashing
- 11) Dormer cheeks
- 12) Sarking
- 13) Roof felt
- (14) Trusses
- 15) Collar
- (16) Insulation
- 17) Parapet gutter
- (18) Eaves guttering
- 19) Rainwater downpipe
- Verge boards /skews
- (21) Soffit boards
- 22) Partition wall
- 23) Lath / plaster
- × ... .
- (24) Chimney breast
- 25) Window pointing
- 26) Window sills
- (27) Rendering
- (28) Brickwork / pointing
- (29) Bay window projection
- (30) Lintels
- (31) Cavity walls / wall ties
- 32) Subfloor ventilator
- 33) Damp proof course
- 34) Base course
- 35) Foundations
- 36) Solum
- 37) Floor joists
- 38) Floorboards
- 9) Water tank
- 40) Hot water tank
