Home report

property questionnaire

Property address	25 Bonnethill Place Dundee DD1 2AD
-------------------------	--

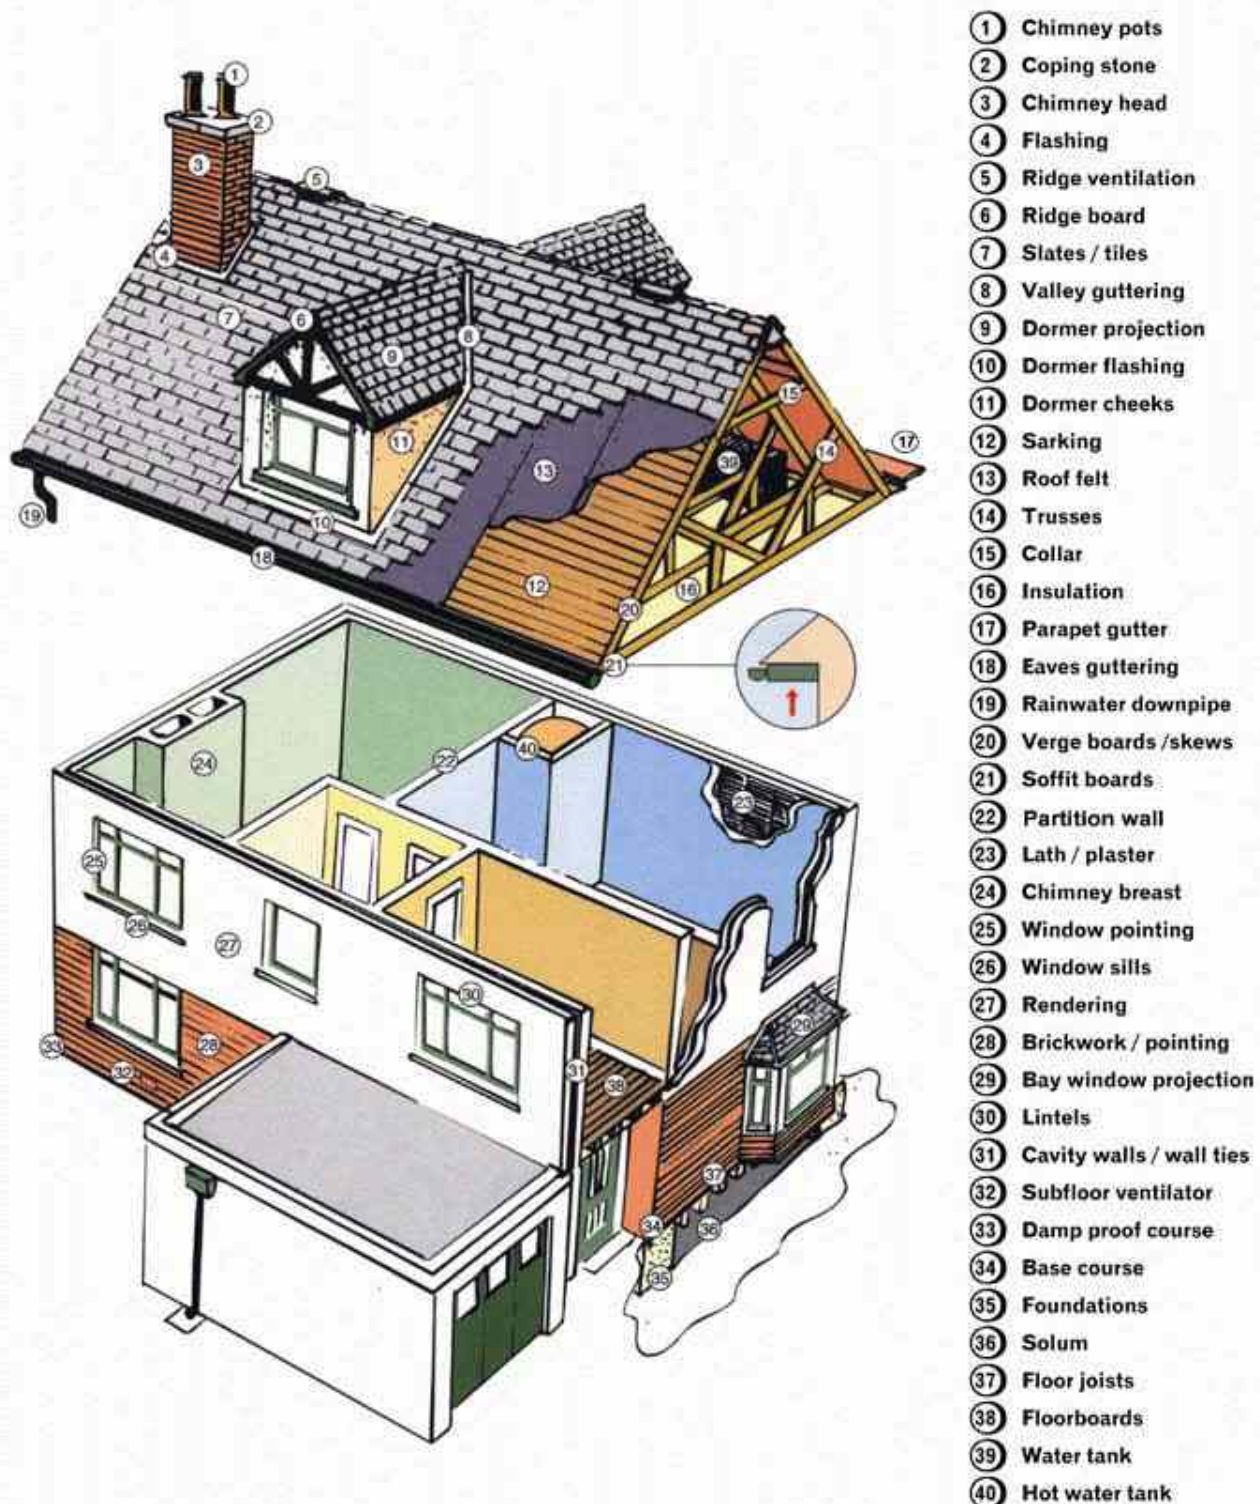
Sectional Diagram showing elements of a typical house

Reference may be made in this report to some or all of the above component parts of the property. This diagram may assist you in locating and understanding these items.
