Home report

Property address

WHITE GABLES

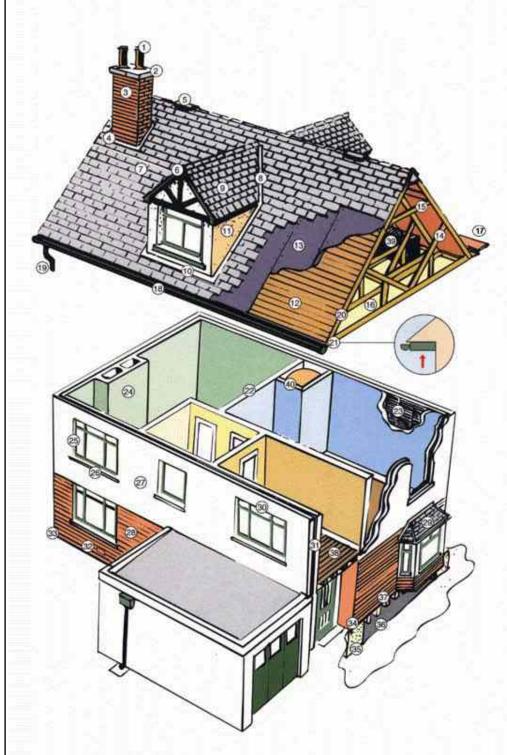
Sectional Diagram showing elements of a typical house

Reference may be made in this report to some or all of the above component parts of the property. This diagram may assist you in locating and understanding these items.

- 1) Chimney pots
- 2) Coping stone
- 3) Chimney head
- 4) Flashing
- (5) Ridge ventilation
- 6) Ridge board
- 7) Slates / tiles
- (8) Valley guttering
- 9) Dormer projection
- 10 Dormer flashing
- 11) Dormer cheeks
- 12) Sarking
- 13) Roof felt
- (14) Trusses
- 15) Collar
- (16) Insulation
- 17) Parapet gutter
- 18) Eaves guttering
- 19) Rainwater downpipe
- O Verge boards /skews
- 21) Soffit boards
- 22) Partition wall
- 23) Lath / plaster
- 24) Chimney breast
- (25) Window pointing
- S
- 26) Window sills
- (27) Rendering
- 28) Brickwork / pointing
- 29) Bay window projection
- 30 Lintels
- (31) Cavity walls / wall ties
- 32) Subfloor ventilator
- 33) Damp proof course
- 34) Base course
- 35) Foundations
- 36) Solum
- 37) Floor joists
- 38) Floorboards
- 9) Water tank
- 40) Hot water tank
