Home report

Property address	16 PRINCES STREET MONIFIETH ANGUS
	DD5 4AN
Seller(s)	MR & Mrs Tracy and Colin Chalmers
Completion date of property guestionnaire	7 th july 2020

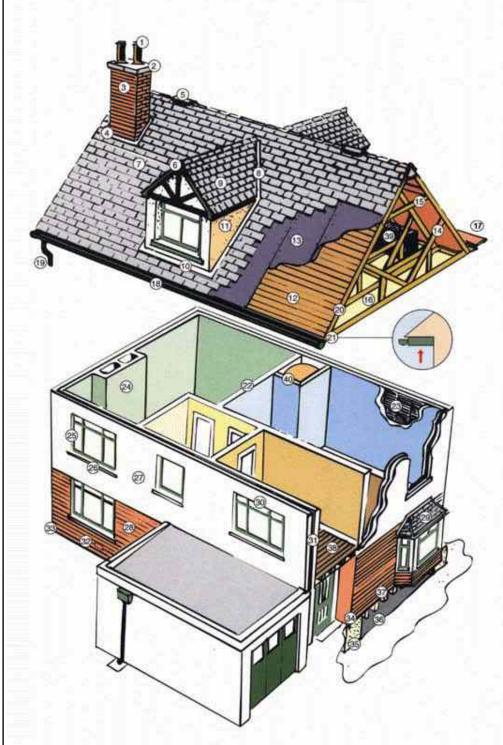
Sectional Diagram showing elements of a typical house

Reference may be made in this report to some or all of the above component parts of the property. This diagram may assist you in locating and understanding these items.

- 1 Chimney pots
- 2 Coping stone
- 3) Chimney head
- 4) Flashing
- (5) Ridge ventilation
- 6) Ridge board
- 7) Slates / tiles
- 8 Valley guttering
- 9) Dormer projection
- 10 Dormer flashing
- 11) Dormer cheeks
- (12) Sarking
- (13) Roof felt
- (14) Trusses
- 15) Collar
- (16) Insulation
- 17) Parapet gutter
- 18) Eaves guttering
- 19) Rainwater downpipe
- 0) Verge boards /skews
- 21) Soffit boards
- 22) Partition wall
- 23) Lath / plaster
- 24) Chimney breast
- (25) Window pointing
- S
- ②6) Window sills
- (27) Rendering
- (28) Brickwork / pointing
- (29) Bay window projection
- 30 Lintels
- (31) Cavity walls / wall ties
- 32) Subfloor ventilator
- 33) Damp proof course
- 34) Base course
- 35) Foundations
- 36) Solum
- 37) Floor joists
- 8) Floorboards
- 9) Water tank
- 40) Hot water tank
