# Home report

# property questionnaire

| <b>Property address</b> | 18 Panmure Street<br>Monifieth<br>DD5 4EB |

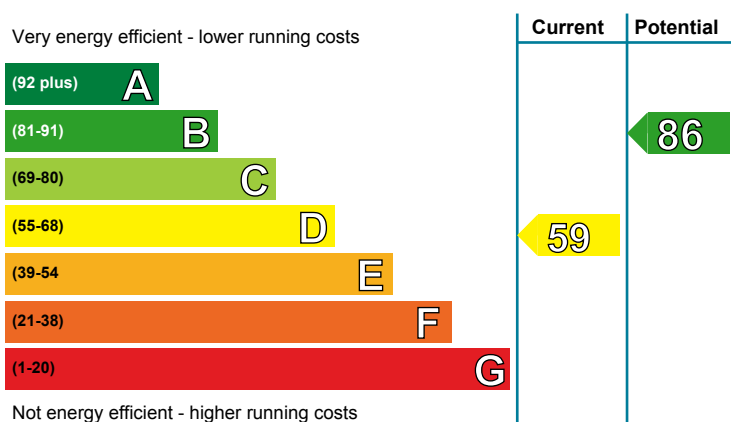
## Energy Efficiency Rating

This graph shows the current efficiency of your home, taking into account both energy efficiency and fuel costs. The higher this rating, the lower your fuel bills are likely to be.

Your current rating is **band D (59)**. The average rating for EPCs in Scotland is **band D (61)**.

The potential rating shows the effect of undertaking all of the improvement measures listed within your recommendations report.

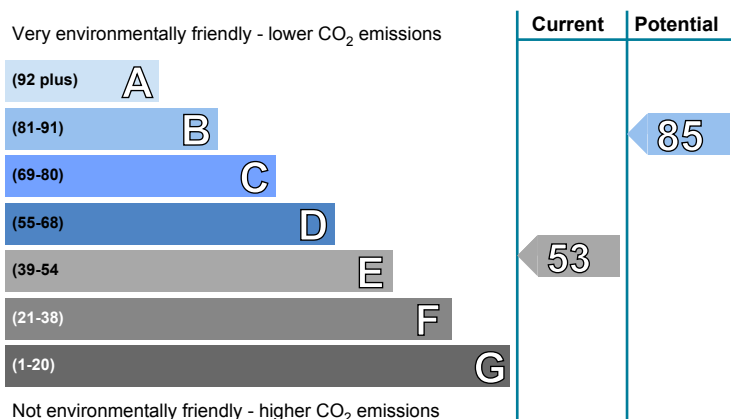
## Environmental Impact (CO<sub>2</sub>) Rating

This graph shows the effect of your home on the environment in terms of carbon dioxide (CO<sub>2</sub>) emissions. The higher the rating, the less impact it has on the environment.

The potential rating shows the effect of undertaking all of the improvement measures listed within your recommendations report.
