Home report

Property address	15c Hindmarsh Avenue Dundee DD3 7LT
Seller(s)	Jennifer Pert
Completion date of property questionnaire	22/07/2020

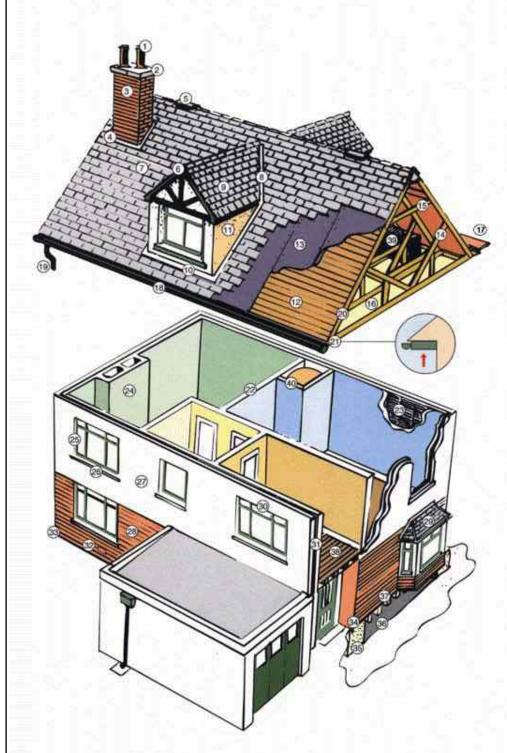
Sectional Diagram showing elements of a typical house

Reference may be made in this report to some or all of the above component parts of the property. This diagram may assist you in locating and understanding these items.

- 1 Chimney pots
- 2) Coping stone
- 3) Chimney head
- 4) Flashing
- 5 Ridge ventilation
- 6) Ridge board
- 7) Slates / tiles
- (8) Valley guttering
- 9) Dormer projection
- 10 Dormer flashing
- 11 Dormer cheeks
- 12) Sarking
- (13) Roof felt
- (14) Trusses
- 15) Collar
- (16) Insulation
- 17) Parapet gutter
- 18) Eaves guttering
- 19) Rainwater downpipe
- 0) Verge boards /skews
- 21) Soffit boards
- 22) Partition wall
- 23) Lath / plaster
- 24) Chimney breast
- (25) Window pointing
- Window sills
- (27) Rendering
- 28) Brickwork / pointing
- 29) Bay window projection
- (30) Lintels
- (31) Cavity walls / wall ties
- 32) Subfloor ventilator
- 33) Damp proof course
- 34) Base course
- 35) Foundations
- 36) Solum
- 37) Floor joists
- 38) Floorboards
- 39) Water tank
- (40) Hot water tank
