# Home report

<b>Property address</b>	18 Stirling Avenue Dundee DD3 6JY
-------------------------	---

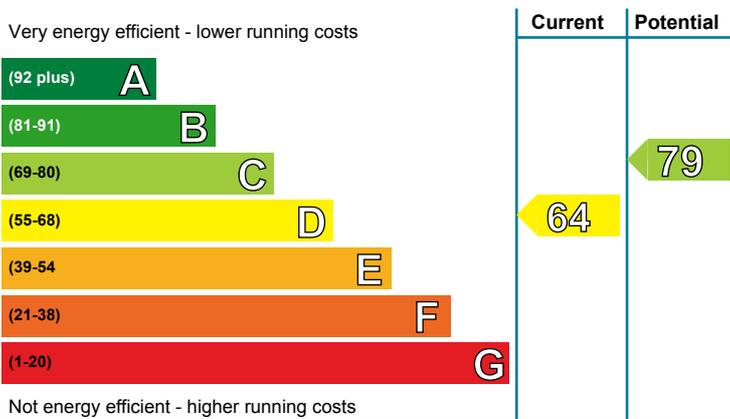
## Energy Efficiency Rating

This graph shows the current efficiency of your home, taking into account both energy efficiency and fuel costs. The higher this rating, the lower your fuel bills are likely to be.

Your current rating is **band D (64)**. The average rating for EPCs in Scotland is **band D (61)**.

The potential rating shows the effect of undertaking all of the improvement measures listed within your recommendations report.

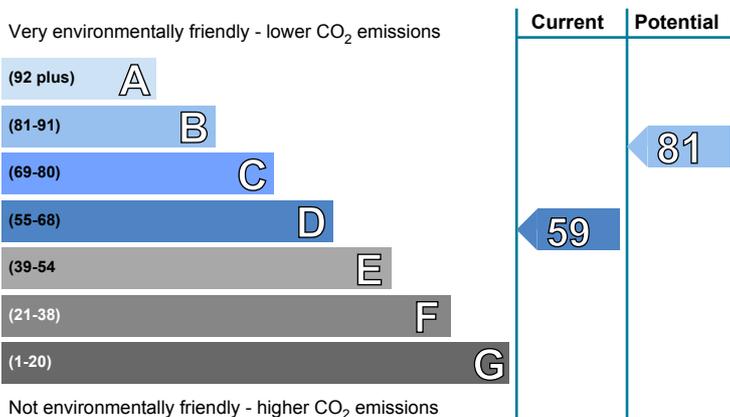
## Environmental Impact (CO<sub>2</sub>) Rating

This graph shows the effect of your home on the environment in terms of carbon dioxide (CO<sub>2</sub>) emissions. The higher the rating, the less impact it has on the environment.

The potential rating shows the effect of undertaking all of the improvement measures listed within your recommendations report.
