# Home report

Kirkhill,  
Dundee Road,  
Meigle,  
BLAIRGOWRIE,  
Perthshire,  
PH12 8SF

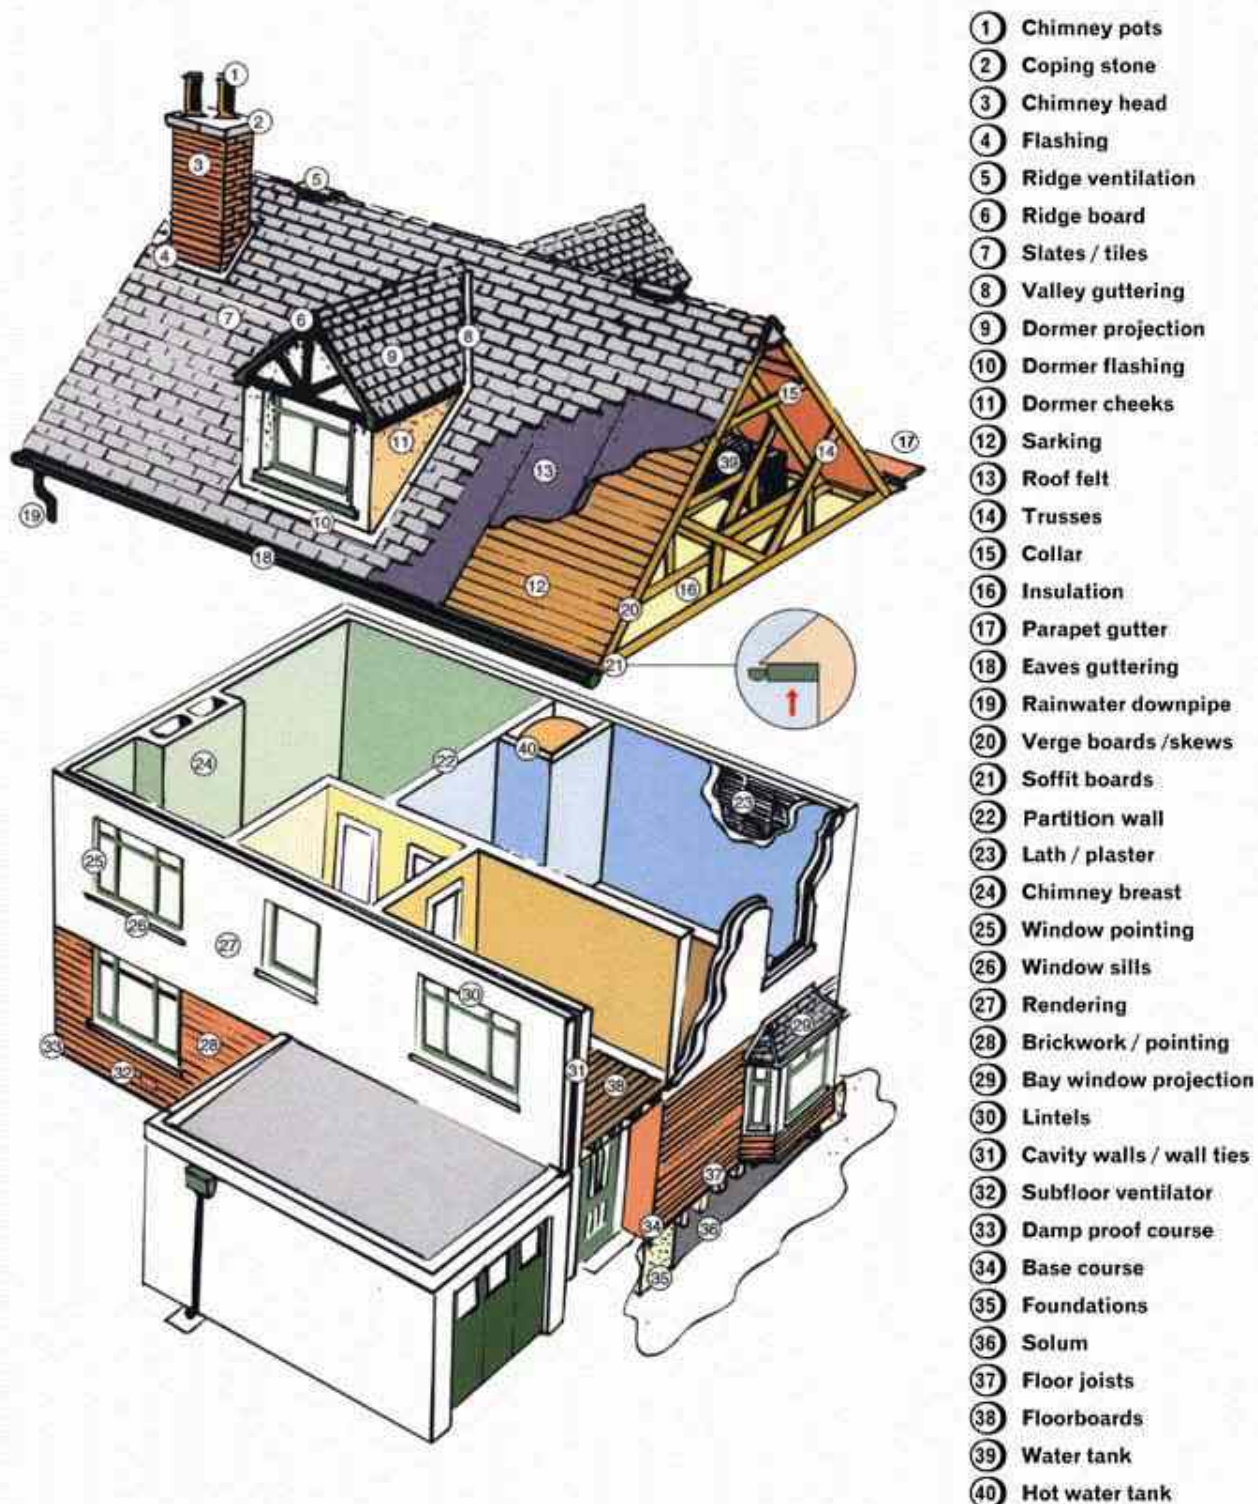
## Sectional Diagram showing elements of a typical house

Reference may be made in this report to some or all of the above component parts of the property. This diagram may assist you in locating and understanding these items.
