Home report

39 BROTHOCK WAY
ARBROATH
DD11 4BH

Home Report

39 BROTHOCK WAY, ARBROATH, DD11 4BH

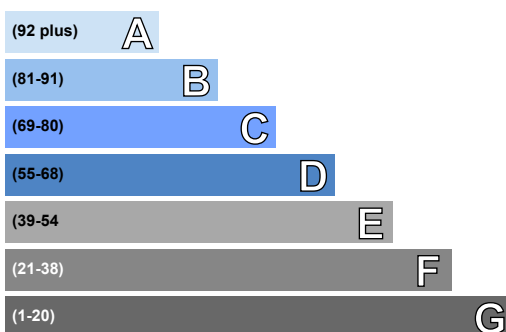
Very environmentally friendly - lower CO₂ emissions

Not environmentally friendly - higher CO₂ emissions

Current	Potential
70	89

The potential rating shows the effect of undertaking all of the improvement measures listed within your recommendations report.

The average Scottish household produces about 6 tonnes of carbon dioxide every year. Based on this assessment, heating and lighting this home currently produces approximately 3.0 tonnes of carbon dioxide every year. Adopting recommendations in this report can reduce emissions and protect the environment. If you were to install all of these recommendations this could reduce emissions by 1.8 tonnes per year. You could reduce emissions even more by switching to renewable energy sources.
