# Home Report

78A Clepington Road  
Dundee  
DD3 7SW

Date of Valuation: 13/03/2020  
AIMS Ref: GT/MD/CD/2020/03/0077

<b>Property address</b>	78A Clepington Road  Dundee DD3 7SW
<b>Customer</b>	Hillcrest Enterprises Ltd
<b>Prepared by</b>	Graham + Sibbald (GT/MD/CD/2020/03/0077)

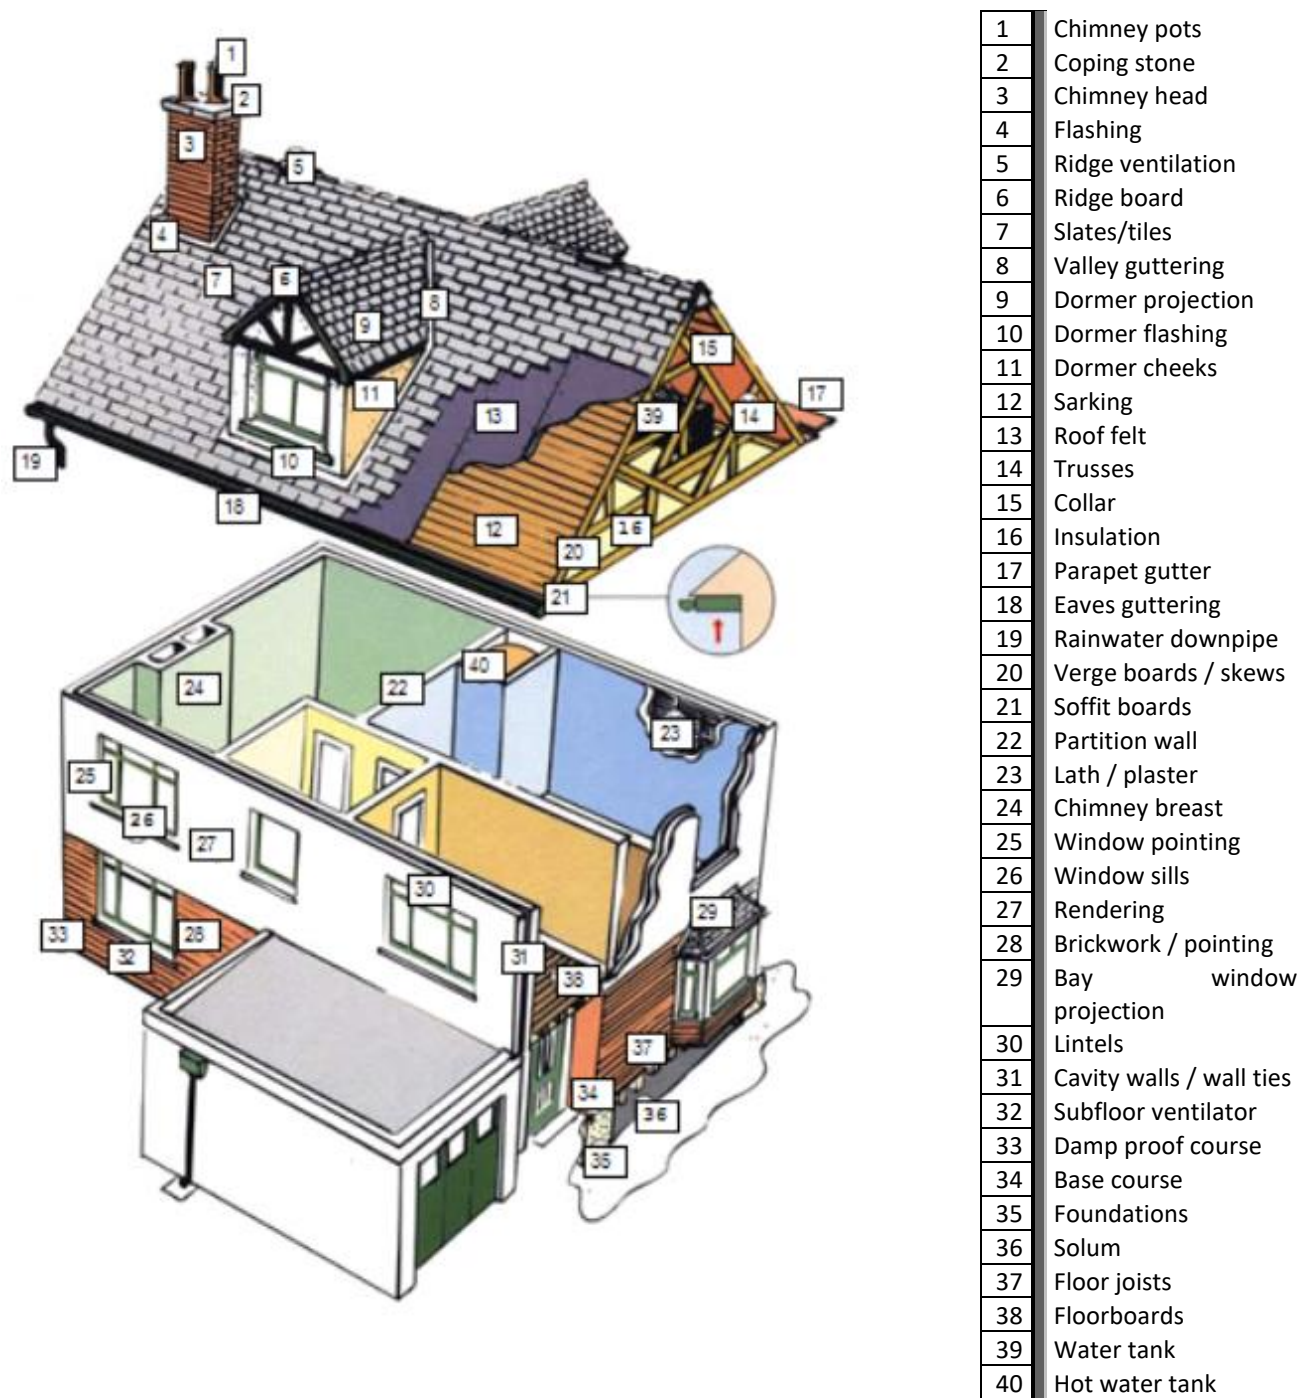
# Sectional Diagram showing elements of a typical house

Reference may be made in this report to some or all of the above component parts of the property. This diagram may assist you in locating and understanding these items.

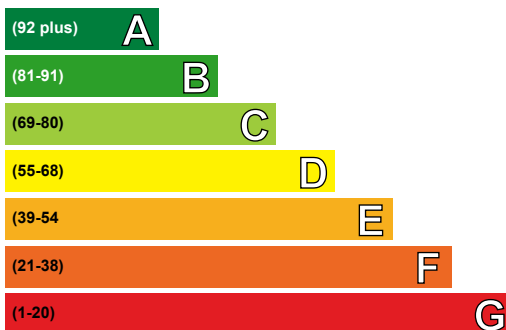
Very energy efficient - lower running costs

Not energy efficient - higher running costs

Current	Potential
66	75
