# HOME REPORT

DILLAVAIRD FARMHOUSE ALYTH

BLAIRGOWRIE  
PH11 8JU

# Single Survey

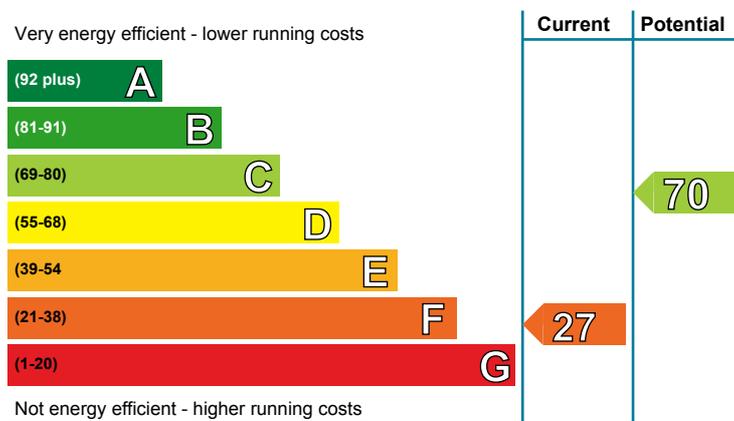
## Energy Efficiency Rating

This graph shows the current efficiency of your home, taking into account both energy efficiency and fuel costs. The higher this rating, the lower your fuel bills are likely to be.

Your current rating is **band F (27)**. The average rating for EPCs in Scotland is **band D (61)**.

The potential rating shows the effect of undertaking all of the improvement measures listed within your recommendations report.

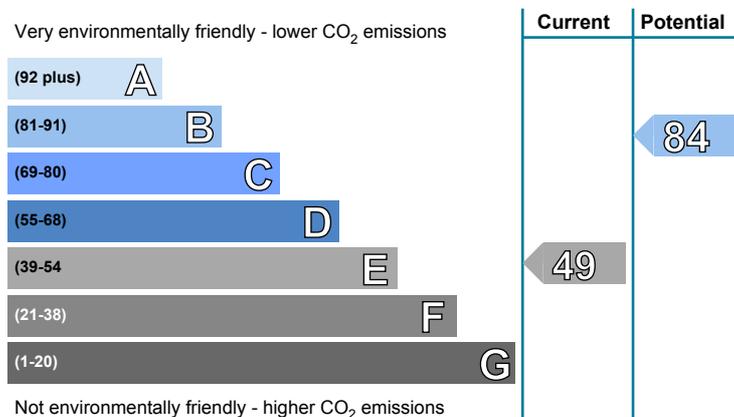
## Environmental Impact (CO<sub>2</sub>) Rating

This graph shows the effect of your home on the environment in terms of carbon dioxide (CO<sub>2</sub>) emissions. The higher the rating, the less impact it has on the environment.

The potential rating shows the effect of undertaking all of the improvement measures listed within your recommendations report.
