# Home report

# property questionnaire

| <b>Property address</b> | /2/R 490 Strathmartine Road , Dundee, DD3 9BP |

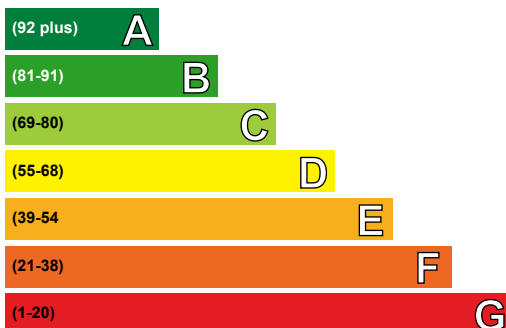
Very energy efficient - lower running costs

Not energy efficient - higher running costs

The potential rating shows the effect of undertaking all of the improvement measures listed within your recommendations report.

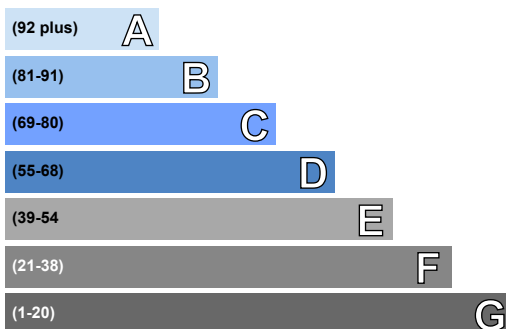
Very environmentally friendly - lower CO<sub>2</sub> emissions

Not environmentally friendly - higher CO<sub>2</sub> emissions

The potential rating shows the effect of undertaking all of the improvement measures listed within your recommendations report.
