Home report

Property address	4 Panmure Street, Monifieth, Dundee, DD5 4EB
Seller(s)	Mrs. Joyce Samson and Mr. Brian Weir as Executors of the late Albert Weir
Completion date of property questionnaire	17.8.20

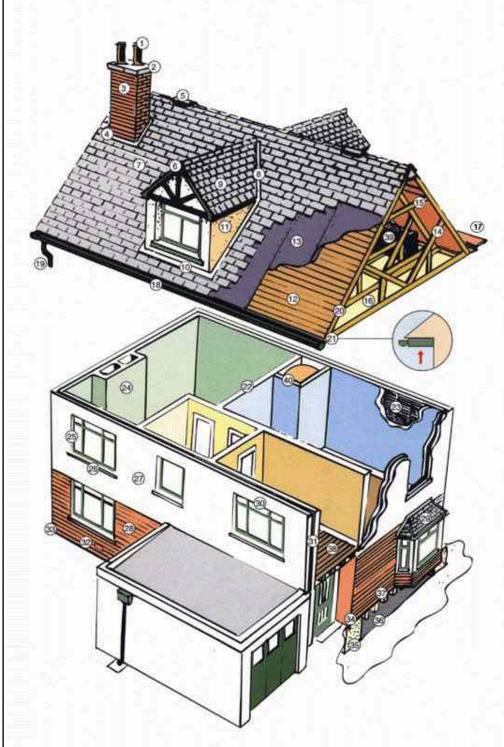
Sectional Diagram showing elements of a typical house

Reference may be made in this report to some or all of the above component parts of the property. This diagram may assist you in locating and understanding these items.

- 1 Chimney pots
- 2 Coping stone
- 3) Chimney head
- 4) Flashing
- 5) Ridge ventilation
- 6) Ridge board
- 7) Slates / tiles
- (8) Valley guttering
- 9) Dormer projection
- 10 Dormer flashing
- (11) Dormer cheeks
- 12) Sarking
- (13) Roof felt
- (14) Trusses
- 15) Collar
- (16) Insulation
- 17) Parapet gutter
- (18) Eaves guttering
- 19) Rainwater downpipe
- 0) Verge boards /skews
- (21) Soffit boards
- 22) Partition wall
- 23) Lath / plaster
- ×
- (24) Chimney breast
- 25) Window pointing
- 26) Window sills
- (27) Rendering
- (28) Brickwork / pointing
- 29) Bay window projection
- (30) Lintels
- (31) Cavity walls / wall ties
- 32) Subfloor ventilator
- (33) Damp proof course
- 34) Base course
- 35) Foundations
- 36) Solum
- 37) Floor joists
- 38) Floorboards
- 39) Water tank
- 40) Hot water tank
