Home report

Property address	53 1L Fort Street Broughty Ferry Dundee DD5 2AB	y
Seller(s)	John Black	
Completion date of property	01/09/2020

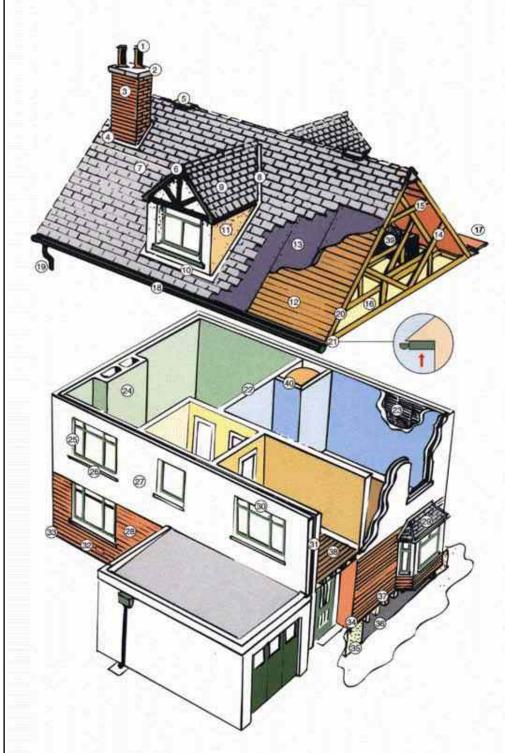
Sectional Diagram showing elements of a typical house

Reference may be made in this report to some or all of the above component parts of the property. This diagram may assist you in locating and understanding these items.

- 1 Chimney pots
- 2 Coping stone
- 3) Chimney head
- 4) Flashing
- (5) Ridge ventilation
- 6) Ridge board
- 7) Slates / tiles
- (8) Valley guttering
- 9 Dormer projection
- 10 Dormer flashing
- 11) Dormer cheeks
- 12) Sarking
- (13) Roof felt
- (14) Trusses
- 15) Collar
- (16) Insulation
- 17) Parapet gutter
- 18) Eaves guttering
- 19) Rainwater downpipe
- 0) Verge boards /skews
- (21) Soffit boards
- 22) Partition wall
- 23) Lath / plaster
- 24) Chimney breast
- (25) Window pointing
- 26) Window sills
- ă . . .
- (27) Rendering
- 28) Brickwork / pointing
- 29 Bay window projection
- (30) Lintels
- (31) Cavity walls / wall ties
- 32) Subfloor ventilator
- 33) Damp proof course
- 34) Base course
- 35) Foundations
- 36) Solum
- 37) Floor joists
- 8) Floorboards
- 39) Water tank
- (40) Hot water tank
