# Home report

# property questionnaire

| <b>Property address</b> | Horizon<br>26 West Road<br>Newport on Tay<br>Fife<br>DD6 8HG |

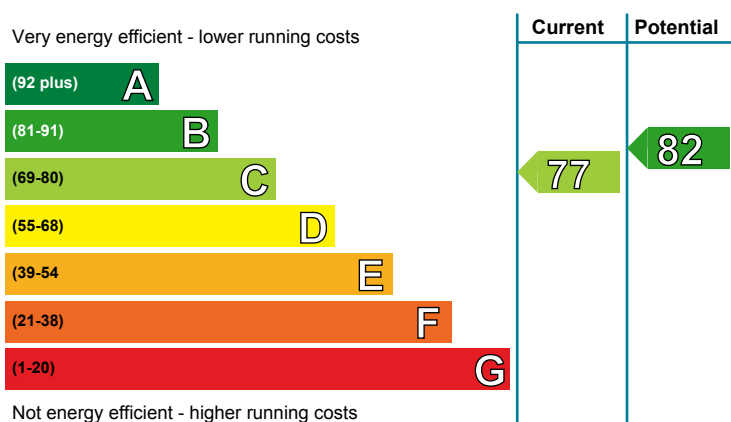
## Energy Efficiency Rating

This graph shows the current efficiency of your home, taking into account both energy efficiency and fuel costs. The higher this rating, the lower your fuel bills are likely to be.

Your current rating is **band C (77)**. The average rating for EPCs in Scotland is **band D (61)**.

The potential rating shows the effect of undertaking all of the improvement measures listed within your recommendations report.

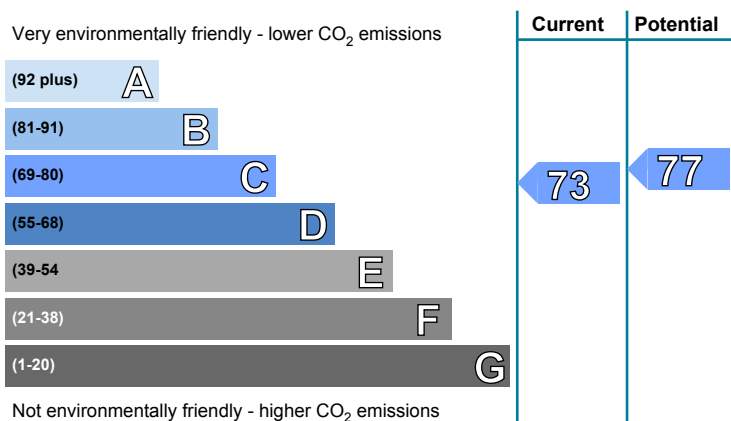
## Environmental Impact (CO<sub>2</sub>) Rating

This graph shows the effect of your home on the environment in terms of carbon dioxide (CO<sub>2</sub>) emissions. The higher the rating, the less impact it has on the environment.

The potential rating shows the effect of undertaking all of the improvement measures listed within your recommendations report.
