HOME REPORT

3A GREENFIELD PLACE
DUNDEE
DD1 4JR

Energy Performance Certificate (EPC)

Single Survey

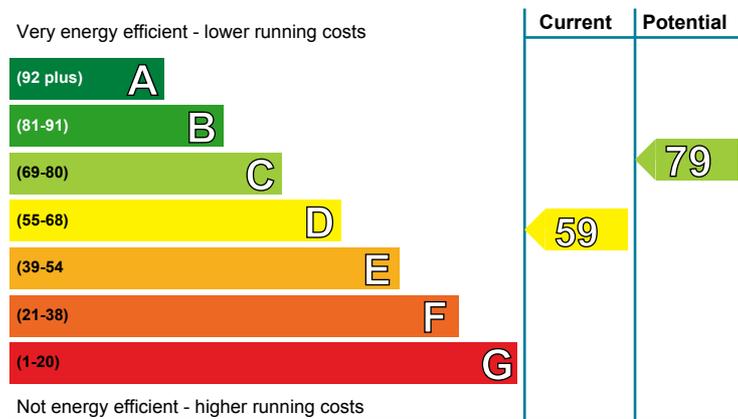
Energy Efficiency Rating

This graph shows the current efficiency of your home, taking into account both energy efficiency and fuel costs. The higher this rating, the lower your fuel bills are likely to be.

Your current rating is **band D (59)**. The average rating for EPCs in Scotland is **band D (61)**.

The potential rating shows the effect of undertaking all of the improvement measures listed within your recommendations report.

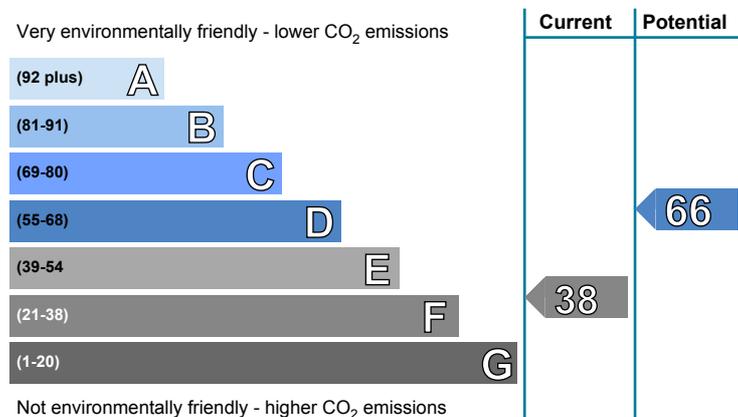
Environmental Impact (CO₂) Rating

This graph shows the effect of your home on the environment in terms of carbon dioxide (CO₂) emissions. The higher the rating, the less impact it has on the environment.

Your current rating is **band F (38)**. The average rating for EPCs in Scotland is **band D (59)**.

The potential rating shows the effect of undertaking all of the improvement measures listed within your recommendations report.
