# Home report

# property questionnaire

| <b>Property address</b> | 32 Marlee Rd<br>Broughty Ferry<br>Dundee<br>DD5 3EX |

# Single Survey

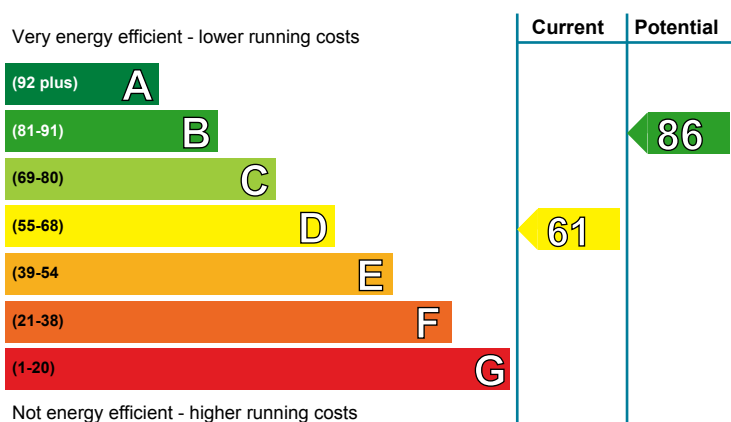
## Energy Efficiency Rating

This graph shows the current efficiency of your home, taking into account both energy efficiency and fuel costs. The higher this rating, the lower your fuel bills are likely to be.

Your current rating is **band D (61)**. The average rating for EPCs in Scotland is **band D (61)**.

The potential rating shows the effect of undertaking all of the improvement measures listed within your recommendations report.

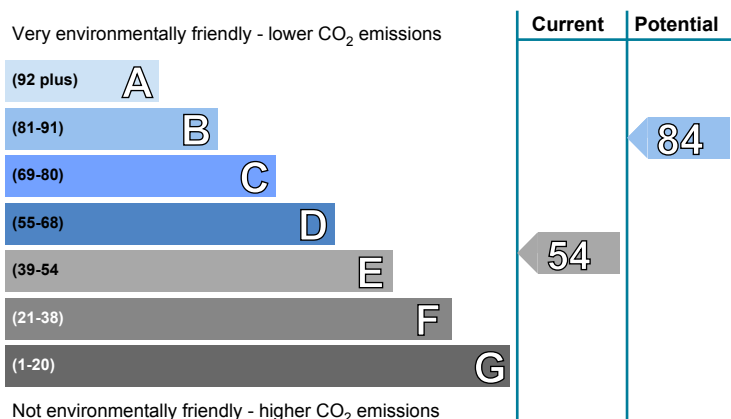
## Environmental Impact (CO<sub>2</sub>) Rating

This graph shows the effect of your home on the environment in terms of carbon dioxide (CO<sub>2</sub>) emissions. The higher the rating, the less impact it has on the environment.
