Home report

property questionnaire

**34, Parkview,
309, Blackness Road,
Dundee.
DD2 1SH.**

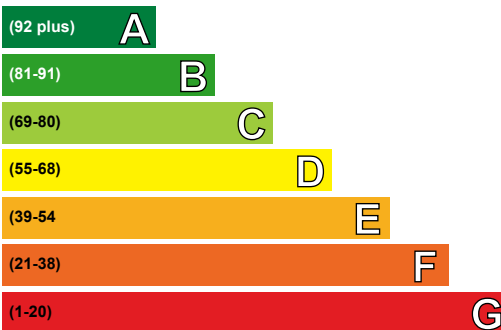
Very energy efficient - lower running costs

Not energy efficient - higher running costs

Current	Potential
82	82

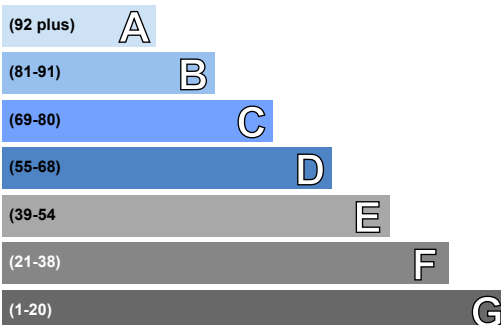
Very environmentally friendly - lower CO₂ emissions

Not environmentally friendly - higher CO₂ emissions

Current	Potential
84	84
